Figure 6A: C001 Radon Analytical Results Map

Canadian Radium and Uranium Site
Mount. Kisco, New York

U.S. ENVIRONMENTAL PROTECTION AGENCY
Removal Support Team 3
CONTRACT # EP-S2-13-01

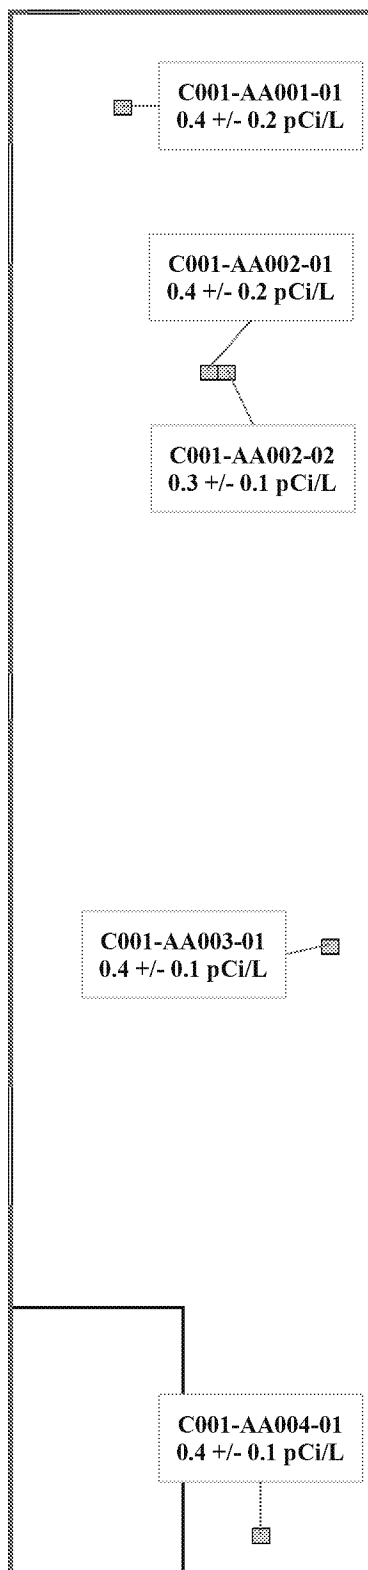
Radon sampling was conducted using charcoal canisters
Radon analytical results are reported in pico curies per liter (pCi/L)
